REPORT OF RCRA COMPLIANCE EVALUATION INSPECTION

OMEGA CAPITAL, LLC

March 25-26, 2014

U.S. ENVIRONMENTAL PROTECTION AGENCY

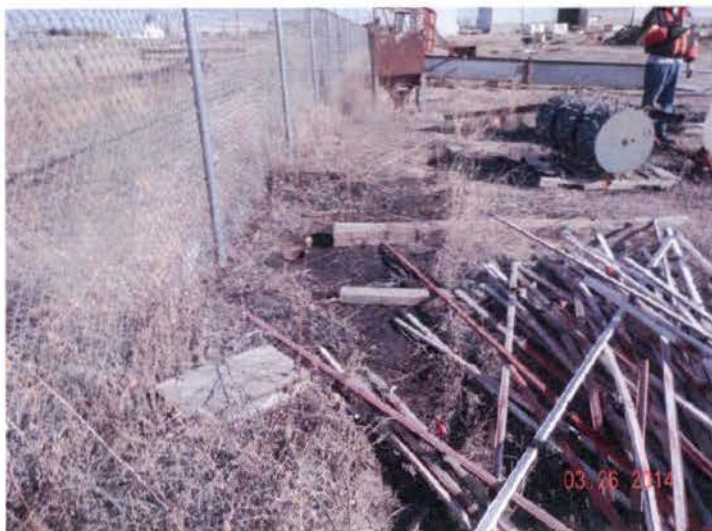
PHOTO 48, 3/26/2014 (facing S) – Inventory item #3 listed on attachment 4C. The facility location is shown on attachment 4C, page 1 and GPS reading included on attachment 10. D. Newsome *DN*

See the disclosure documents in attachments 6A and 6B for the details OC stated about this claim. There were three main areas that Mr. Williams pointed out as being identified by former employees concerning this claim (see attachment 4C, page 1 and photos 48 through 49 and 54 through 59). They are noted as Area 3, 4 and 5 on attachment 4C, page 1. The GPS readings are included on attachment 10. I observed some dark stains on and just below the surface in the areas as shown in photos 48 through 50 and 55 through 58.

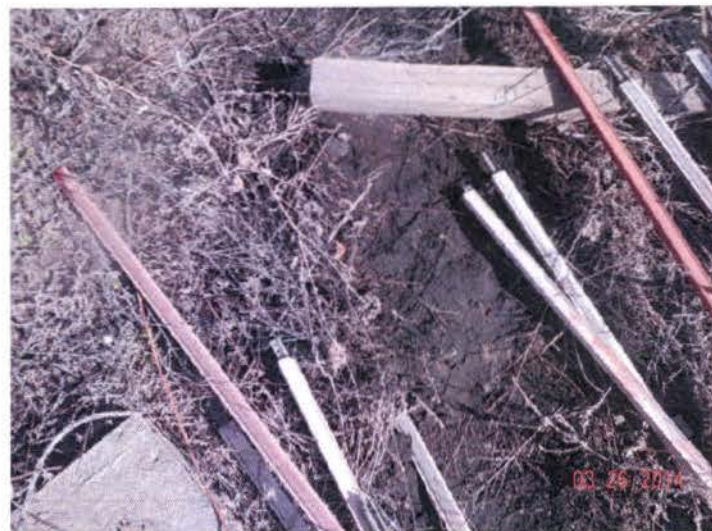
PHOTO 49, 3/26/2014 (facing N) – Inventory item #3 listed on attachment 4C. The facility location is shown on attachment 4C, page 1 and GPS reading included on attachment 10. D. Newsome *DN*

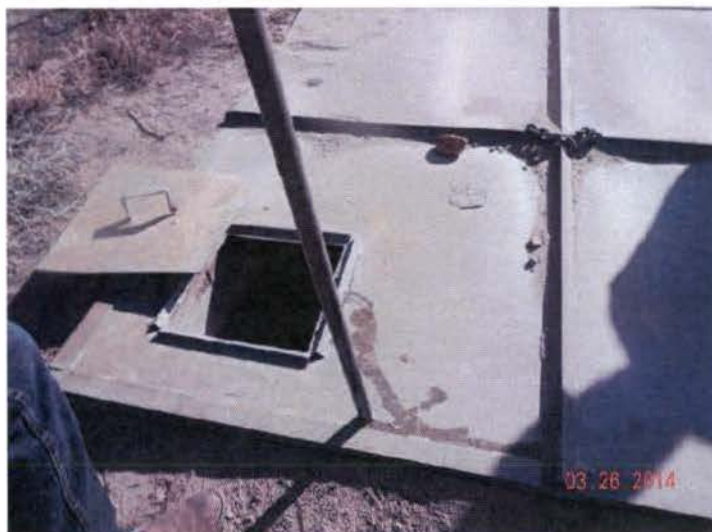
PHOTO 50, 3/26/2014 (facing NW) – Inventory item #3 listed on attachment 4C. The facility location is shown on attachment 4C, page 1 and GPS reading included on attachment 10. D. Newsome *DN*

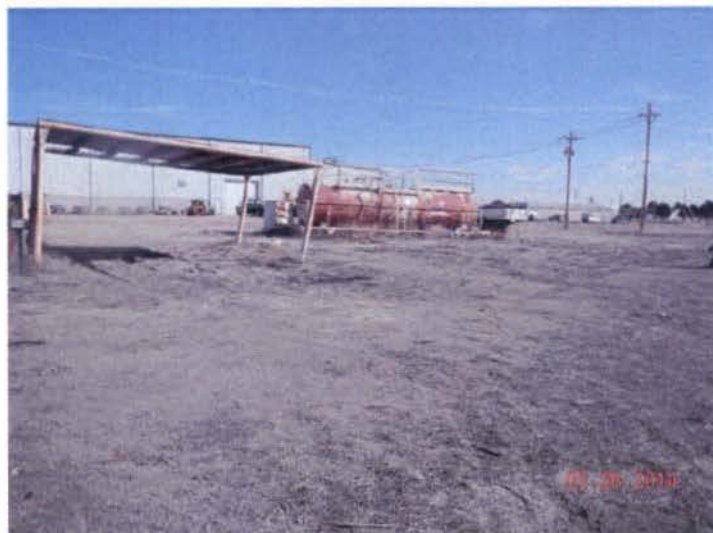
PHOTO 54, 3/26/2014 (facing SW) – Inventory item #4 listed on attachment 4C. The facility location is shown on attachment 4C, page 1 and GPS reading included on attachment 10. D. Newsome *DN*

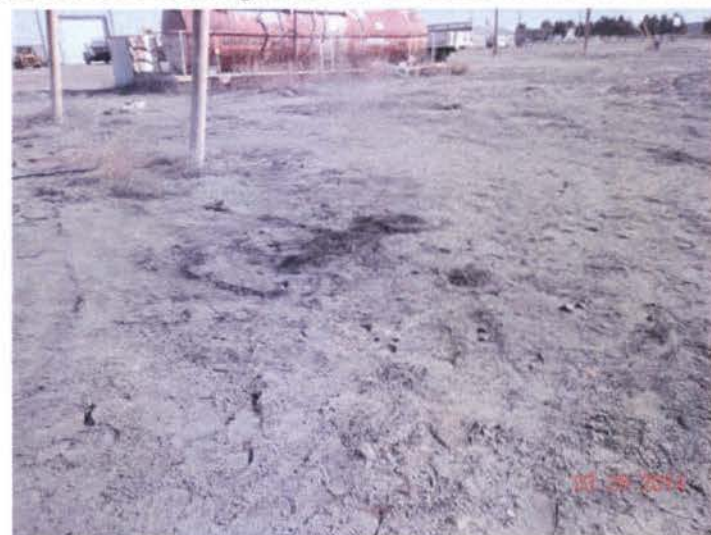
PHOTO 55, 3/26/2014 (facing NE) – Inventory item #4 listed on attachment 4C. The facility location is shown on attachment 4C, page 1 and GPS reading included on attachment 10. D. Newsome *DN*

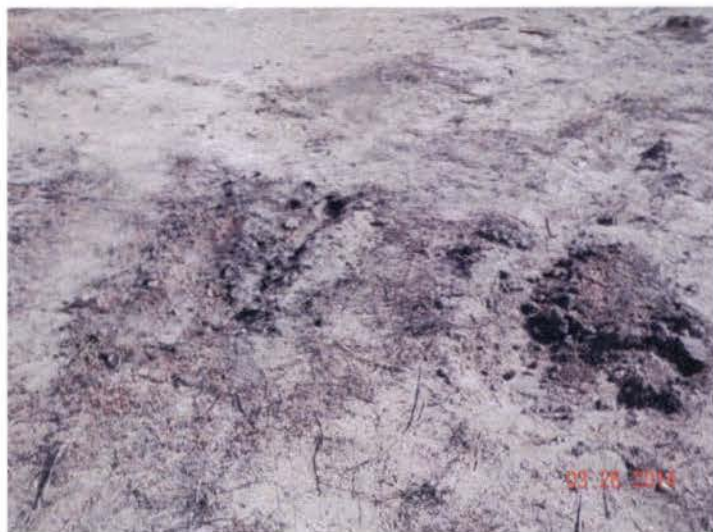
PHOTO 56, 3/26/2014 (facing NE) – Inventory item #4 listed on attachment 4C. The facility location is shown on attachment 4C, page 1 and GPS reading included on attachment 10. D. Newsome *DN*

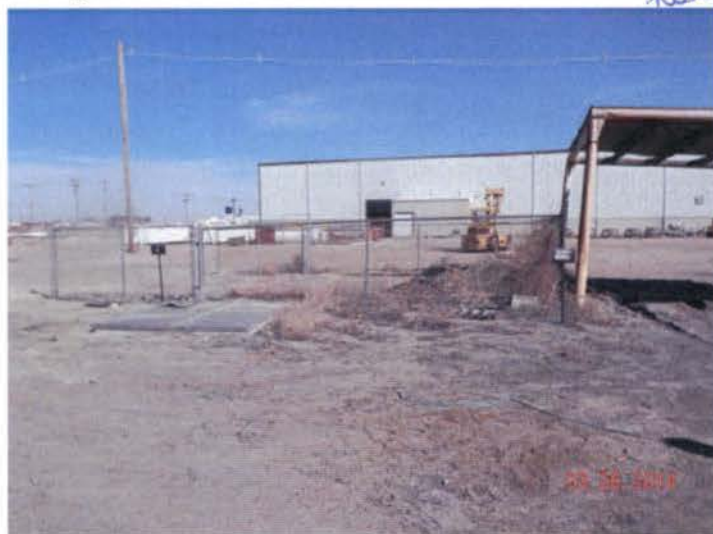
PHOTO 57, 3/26/2014 (facing NE) – Inventory item #4 listed on attachment 4C. The facility location is shown on attachment 4C, page 1 and GPS reading included on attachment 10. D. Newsome *DN*

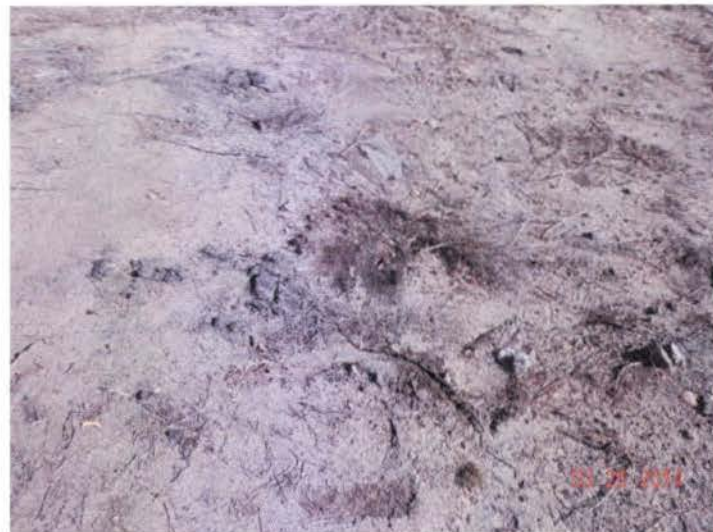
PHOTO 59, 3/26/2014 (facing NW) – Inventory item #4 listed on attachment 4C. The facility location is shown on attachment 4C, page 1 and GPS reading included on attachment 10. D. Newsome *DN*

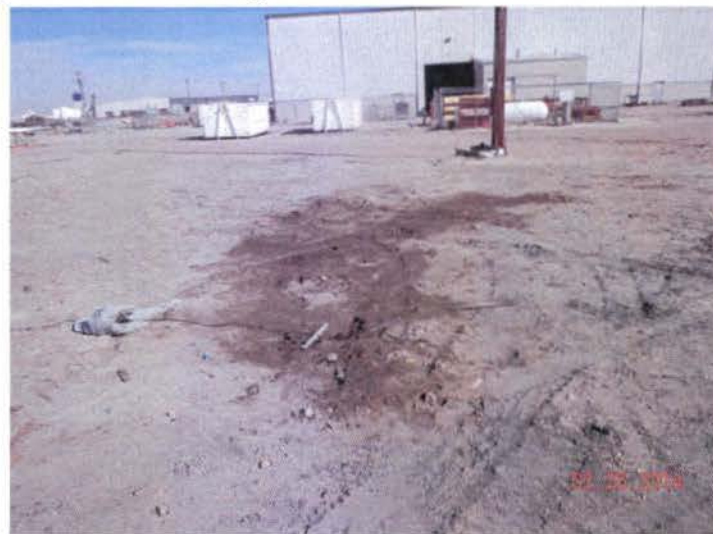
PHOTO 58, 3/26/2014 (facing N) – Inventory item #4 listed on attachment 4C. The facility location is shown on attachment 4C, page 1 and GPS reading included on attachment 10. D. Newsome *DN*

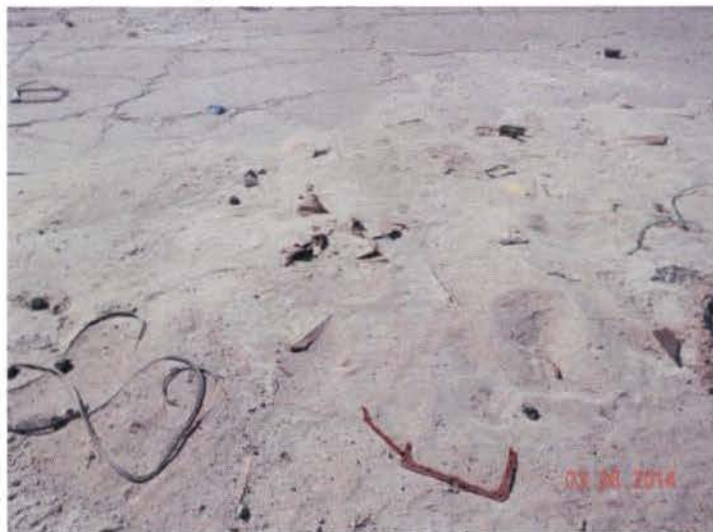
PHOTO 69, 3/26/2014 (facing E) – Inventory item #9 listed on attachment 4C. The facility location is shown on attachment 4C, page 1 and GPS reading included on attachment 10. D. Newsome *NSU*

EPA was informed by OC that on 3/10/2014 the water was turned on in the evaporator unit and ran all night long (see the facility files for more details). Therefore, it overflowed both inside and outside the facility's overhead door (see photo 72) in the area noted as Area 11 on attachment 4C, page 1 (see photo 69). Mr. Williams stated that the overflow settled into three puddles on the ground in Area 11. He stated that they placed pig mats on top of the puddles and vacuumed the remaining wastewater into drums. I observed in the HW Storage Area 11 drums dated 3/11/2014 and labeled either oily water or oily sludge/solid from evaporator spill (see attachment 4A). **A hazardous waste determination was not made on this wastes as required by Title 128, Chapter 4, 002 (see Section 4.5 below and inventory item #9 on attachment 4C**

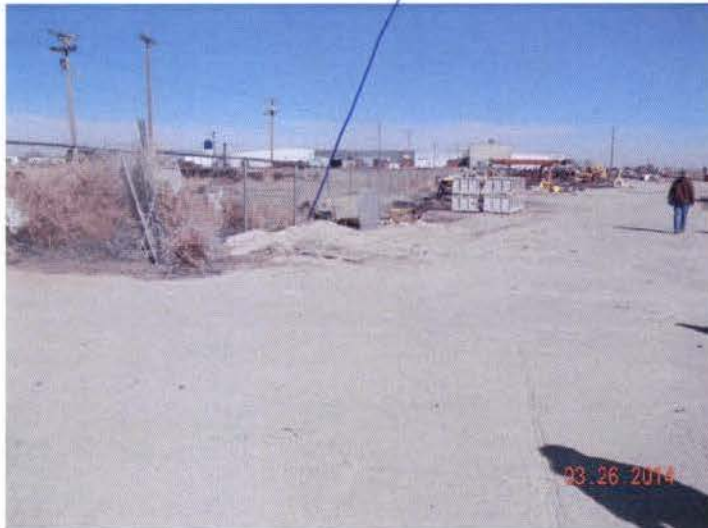
PHOTO 72, 3/26/2014 (facing NE) – Inventory item #11 listed on attachment 4C. The facility location is shown on attachment 4C, page 1 and GPS reading included on attachment 10. D. Newsome *NSU*

*sandblast
Avg. 1/2
trailer
with
blasting
unit*

*overhead
door where
unit leaked
from*

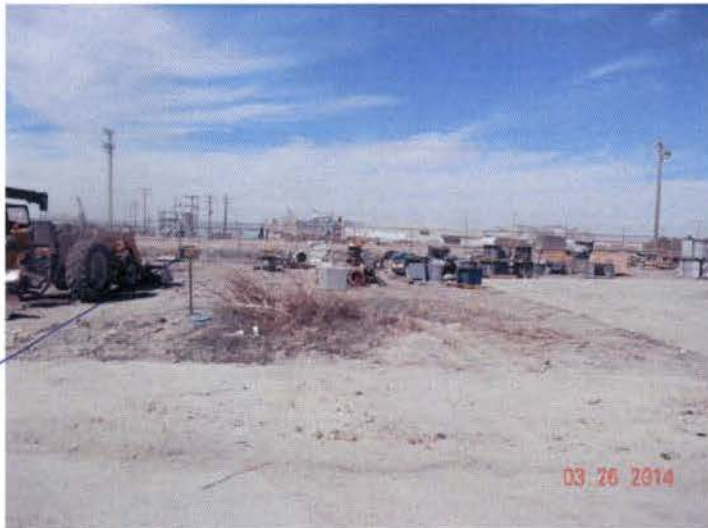
Old Battery Storage Area – Mr. Williams stated that when he was hired, approximately 32 batteries were being stored outside in Area 14 noted on attachment 4C, page 1 and in photo 75. Also, he stated that about 10 batteries were being stored in Area A noted on attachment 4C, page 1, although he was told that up to about 300 batteries were stored in this area in the past. Mr. Williams stated that they moved these batteries being stored outside under the lean-to (see attachment 7B). Also, see Section 4.4 regarding the self-disclosure.

PHOTO 75, 3/26/2014 (facing W) – Old Battery Storage Area as noted on "Scrap Batt" sign. This area is noted as Area 14 on attachment 4C, page 1 and GPS reading included on attachment 10. D. Newsome *DW*

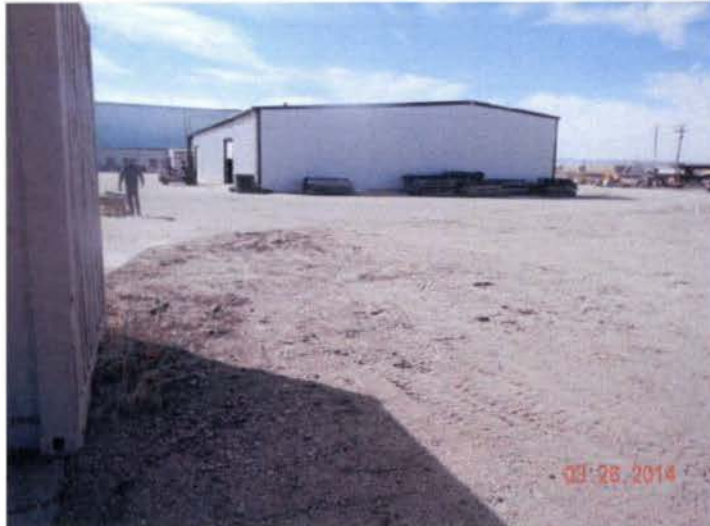
PHOTO 76, 3/26/2014 (facing NE) – Inventory item #12 listed on attachment 4C. The facility location is shown on attachment 4C, page 1 and GPS reading included on attachment 10. D. Newsome *DW*

Mr. Williams stated that Glen Nelson told him that he drilled holes in the legs of the transport containers (see photo 13) so that the liquid waste drained onto the ground in Area 15 which is on an incline (see attachment 4C, page 1, photos 76 and 77 and attachment 10 for GPS reading). Mr. Williams stated that Mr. Nelson told him that the liquid burned like an acid when he came into contact with it. Mr. Williams stated that they had no other information on the liquid waste drained onto the ground. Mr. Williams stated that they did not drill any holes in the battery cell casings themselves and he was not aware of any arriving on-site cracked or broken. **I listed the battery waste disposed on the ground on the NOV for failing to have a hazardous waste**
